Building **Inclusive** Urban Communities

MAPPING LIVABILITY OF LOWER INCOME HOUSING TYPOLOGIES IN THE CITY OF MUMBAI

Keluskar Kimaya – 2017

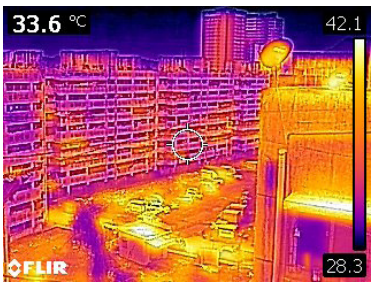
Figure 6

Aerial view of the open ground amidst buildings. The ambient temperature in the latemorning is approximately 40°C; resultant of absence of vegetation on site and high deposit of hard paving non permeable material. This would add to the urban heat island effect. The open space is occupied by illegal car parking, construction waste thus depriving children and inhabitants from using the place for recreational and play related activities.

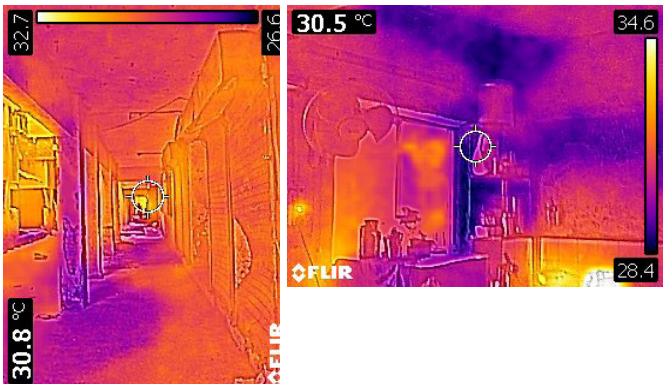
Figure 9 (left)

At 11.00am in the morning the surface temperatures have reached 36.9°C; windows on the right façade show high heat ingress owing to exposure to direct solar radiation. The alcove design allows single-sided ventilation only, this intensify the heat absorbed by the façade throughout the day creating un-comfortable indoor condition.

The corner housing unit at 4th floor; clearly depicts the water leakage within the structural system resulting into dampness. Absence of air circulation indoors, result in high relative humidity levels and mould formation; affecting the health of the occupants. The children suffer from asthama, frequent cough and cold. The electric fans are running continuously to achieve comfortable indoor conditions.

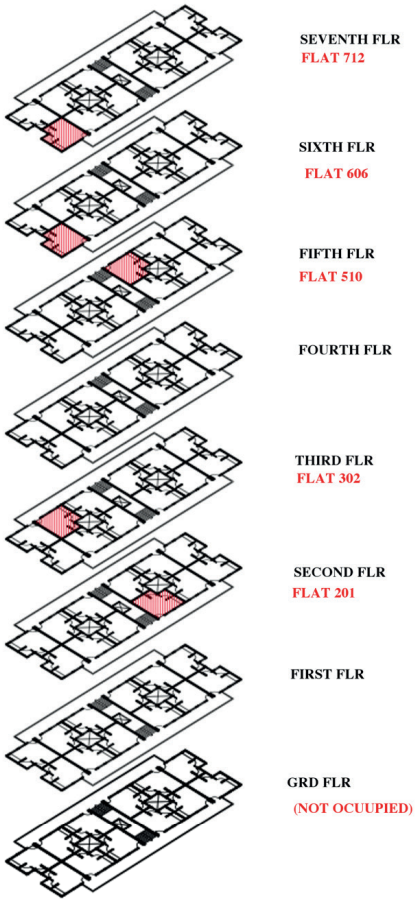
Figure 14

showing position of Dataloggers Installed on site (Building 11C) to map Thermal comfort within units at different levels.

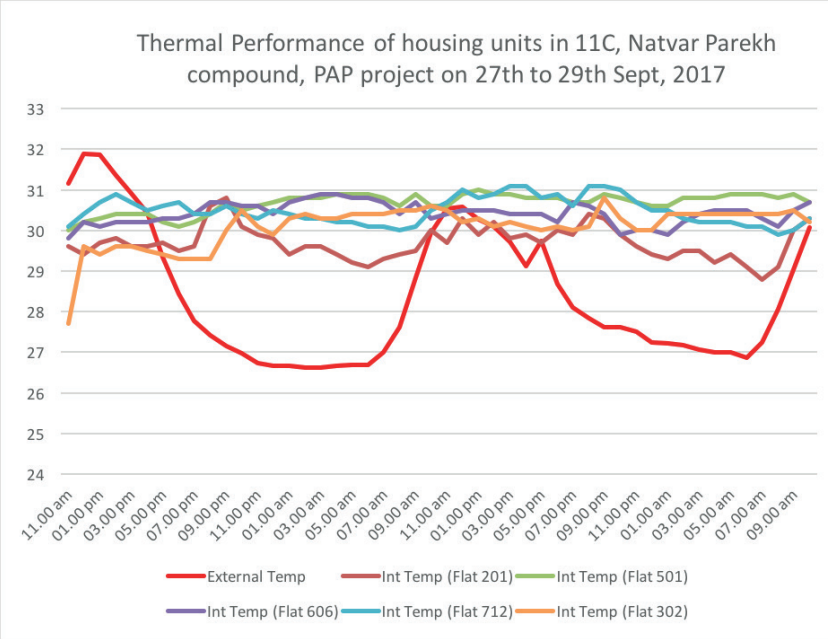
Figure 15

Temperature recordings of housing units monitored

Observation and related projections:
The design iof the housing colony at NPC is highly compromised. The scientific data derived using instruments display some evident facts; the flats placed at the corner are performing slightly better owing to access to outdoor air and ventilation compared to the ones placed in the middle which are totally devoid of daylight and ventilation. The relative humidity in middle units is high resulting into dampness and mould formation on the walls. The flat 501 despite of being middle unit experiences high temperatures throughout the monitored time than the topmost flat 701. This clearly shows absence of ventilation and constant increase in indoor temperatures due to high number of occupants, equipment load and pollutants. The inhabitants at 5th, 3rd and 1st floor are suffering from tuberculosis. As mentioned by Claude-Alain Roulet in chapter on 'Role of Ventilation'; states that the purpose of ventilation is to eliminate airborne contaminants, these are either generated by the occupants and the activities performed within the building. The absence of ventilation is very evident in middle housing units as their interiors smell of bad odour; one experiences the fowl smell on entering these rooms. Readings shows higher levels of CO_2 concentration leading to lethargic indoor environments and experiencing high indoor temperatures indoors even when the outdoor temperatures are low.The topmost floor experience higher temperature but lower relative humidity. This occurs with the excess heat transferred from the terrace and lower RH is resultant of unobstructed induced ventilation being on the higher elevation. These observations and inferences explain that the design requires to be relooked to address basic environmental standards of thermal and visual performance.

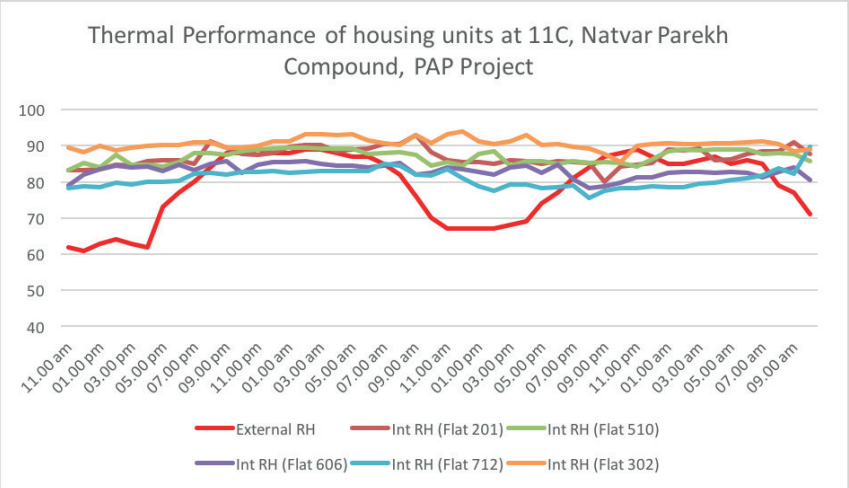
Figure 16

Humididty recordings of housing units monitored

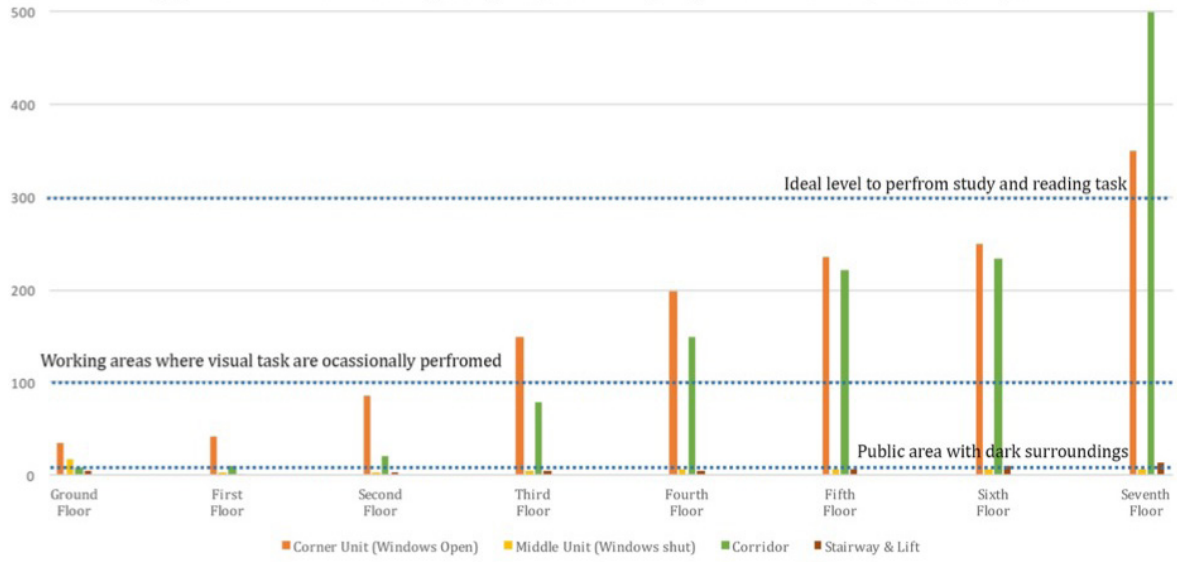
Figure 17

Graph showing readings on site July 2017 @ 2.00pm IST

Daylight is an essential component of indoor environment, to ensure good visual comfort and indoor air quality. The standard lux[6] vary as per space specification and activity to be performed. The graph highlights the incompetent behaviour of spaces with respect to the standards directed by National Building Code(NBC). Common stairway and lift block display poor lux levels and are dependent on artificial light throught out the day. Lux levels in the corridor increase as one acends to higher floors. From the fourth floor the corridor transforms into a comfortable spaces to perform ocassional visual tasks like drying of spices, studies etc. However the daylight level doesn't change for middle unit even at higher floors. Corner unit performs better due to high exposure to the outdoor illumination. Daylight monitoring exercise clearly displays the failure of building design to ensure good daylight penetration within households and common spaces. More than 80% of the household depends on artificial light to perform their daily household ativities exerting high operational and maintenance cost. On an average the middle unit electricity bill accounts to Rs1300 (two tubelight and fan) to Rs 800 (one fan and tubelight) per month reaching 2000Rs in summers. The price excalates with increase in the occupant and quipment laod. The average electricity bill of 450Sqft area in summers accounts to maximum 2500/- Rs considering the air condition operational hours to be 5 to 6 and 1 to 2 hours of gyeser for hot water requirement every day. Each unit in NPC is 225Sqft. The dense housing model shows daylight traces from fourth to seventh floor indictaing the obstacle created by clear distance followed between buildings for daylight penetration. This creates a need to study the obstruction angle its impact on daylight penetration.

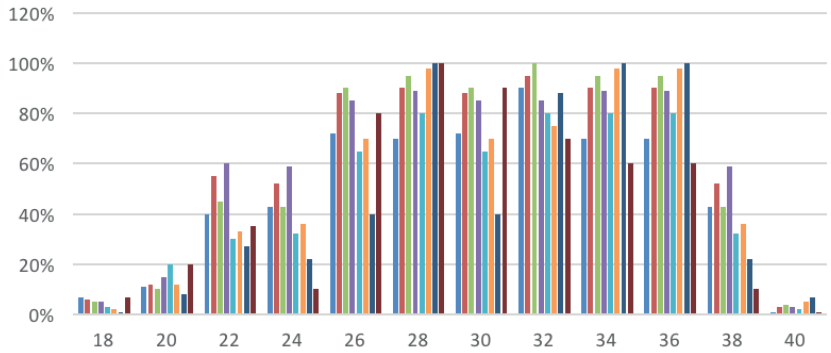
Figure 21

Showing the amount of people comfortable within 11C building and the temperature range that lies under comfort zone as per the inhabitants' vs the Ashrae comfort zone.

As per the NBC 2005 comfortable mean indoor temperatures ranges from 25°C to 30°C for naturally ventilated buildings in India. The Slum dwellers inhabitate in extreme conditions, devoid of daylight, ventilation and sanitation. The slum huts are assembled using tin roof sheet and partitions, using plastic sheet during monsoon to control water leakages. Relocating within multi storey tenement upgrades their standard of living and offers a sense of security which is often mis read as comfort. Hence the vote on comfortability of such inhabitants is generally under rated owing to their extended adaptive capacities. The idea of the house is looked as 'possession' to stack one's belonging, shelter for their dear ones and not seen as inhabitable space with good environmental living conditions to propagate well-being and growth. Similarly, MIG and HIG inhabitants vote on comfort is over rated indicating lower adaptive capacities and reliance owing to its dependency on technology to achieve comfort. This clearly points out why passive design features and comfort are not integral to the upcoming housing colonies within the city. Such oversight has direct impact on the health and quality of life of its inhabitants.

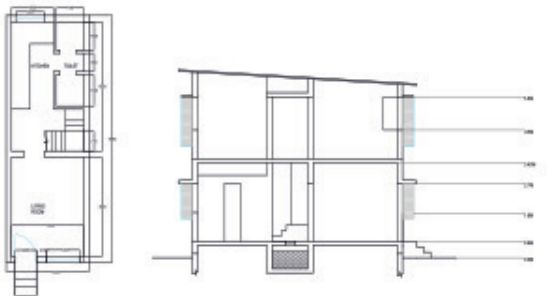
Figure 27

Showing the altered G+1 corner unit. In comparison with the drawings given by MHADA authority, its been noticed that in the process of incorporating more land to suit the space requirement of a family the occupants unknowingly compromise the enviornmnetal performance of the unit by blocking daylight and ventilation.

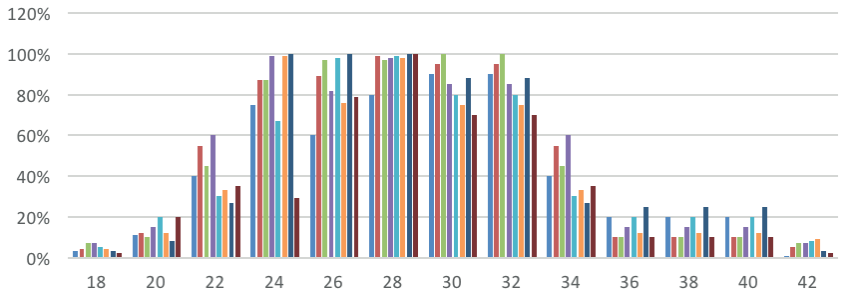
Figure 29

Mean Indoor Temperature in Degree Celcius (NBC 2005 - 24°C to 30°C), showing the adaptive comfort model for site and Services Scheme, Cluster 05.

The comfort temperatures for inhabitants of cluster 05 ranges from 24°C to 32°C which is 2°C more than the comfort levels stated by NBC 2005. The survey points out about one of the adaptive measures considered by the inhabitants is by mitigating clo value. Moreover, the presence of water tank below the ground level help in mainataing cooler indoor emperatures. Majority of the tenements have air conditioner or air cooler installed to meet the comfort conditions indoor especially during during peak summertime.

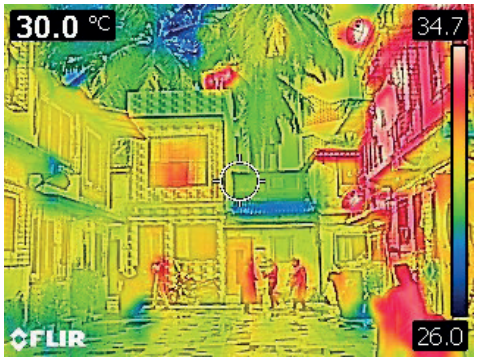
Figure 30 & 31

Internal courts are devoid of plantation and are completely hard paved. Early morning; the ambient temperature of the court is 30°C when the outdoor temperatures are 25.9°C. A difference of approximately 4°C is observed adding to the overall Urban Heat Island effect of the place.

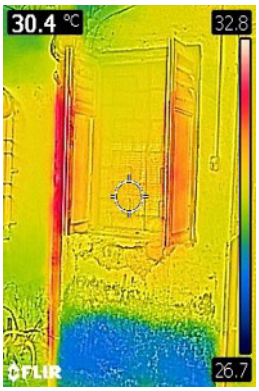
Figure 32, 33, 34 & 35

The cluster consists of different roofing systems and mode of adaptive strategies to combat the weathering conditions. The above figure depicts the thermal behavioural change in materials and its impact on indoor environments. The plastic sheet helps in keeping the water away however results in overheating of rooms below. Moreover the plastic sheet continues to cover the structure throughout the year resulting in high indoor temperatures in peak summer season.

The vertical images depict the thermal behavior of external wall of Bella Aunty's house. The house is retained in its original form the way it was constructed in 1985. The thermal image clearly shows the dampness on the wall (Blue colour Patch) and moss formation. The internal humidity levels are around 90%. The occupants are suffering from respiratory illness and are on constant medication. The house is also closed most of the daytime hours to ensure privacy and security, limiting the daylight penetration and ventilation.

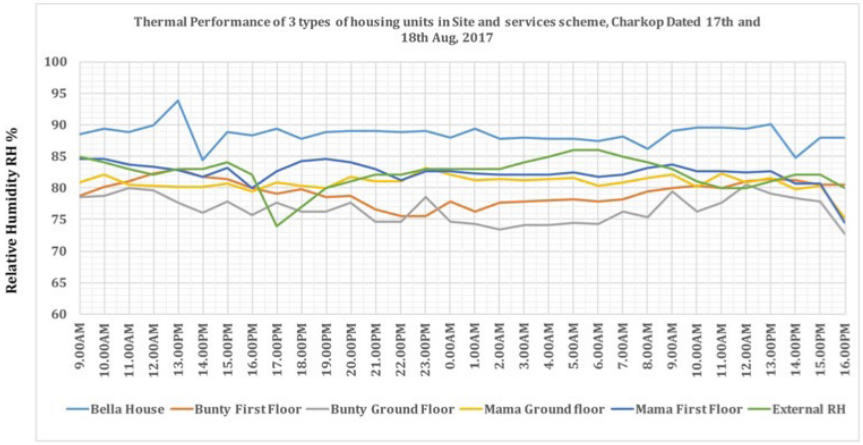
Figure 36

Temperature recordings of housing units monitored.

Above figures clearly demonstrate higher indoor temperatures by approximately 4°C maintained throughout the day in various locations. The heat within the indoor environments is not able to radiate out to reduce indoor temperature. The RH is high for more than 90% of the day exposing the occupants to uncomfortable indoors (feeling suffocating and sticky); direct impact on their health. Negligible levels of ventilation and air change rate results in mould generation because of continuous dampness within the walls of the houses. The tiling resolves the problem visually but does not stop the dampness in spreading. Condenstaion on dado tiles is observed during monsoon. Resulting into 24 hours of operating the mechanical equipment to attain comfort indoor conditions, more than 80% of households depends on artificial lighting and fan.

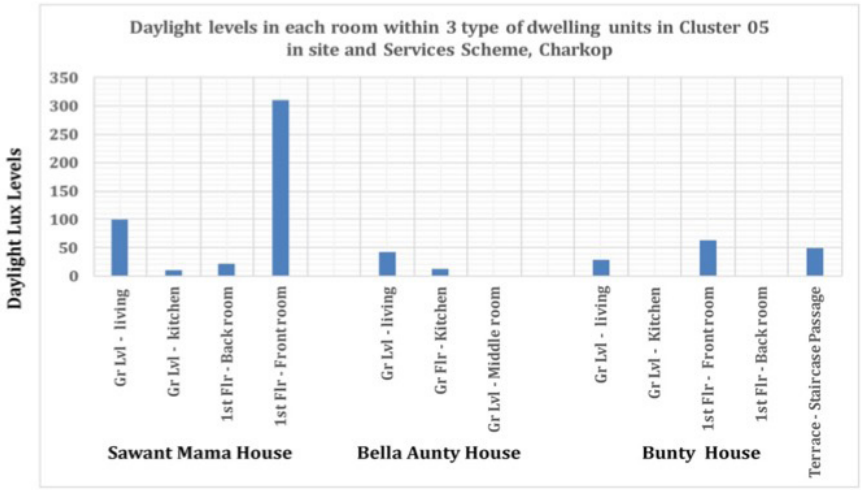
Figure 38

Daylight recordings within housing units monitored.

Daylight performance is very poor in all households except first floor rooms which have larger window openings. The deep narrow plan restricts the daylight to enter after a certain distance. Only the peripheral houses in each cluster has a liberty to place a functional window on the other side to practice cross ventilation.

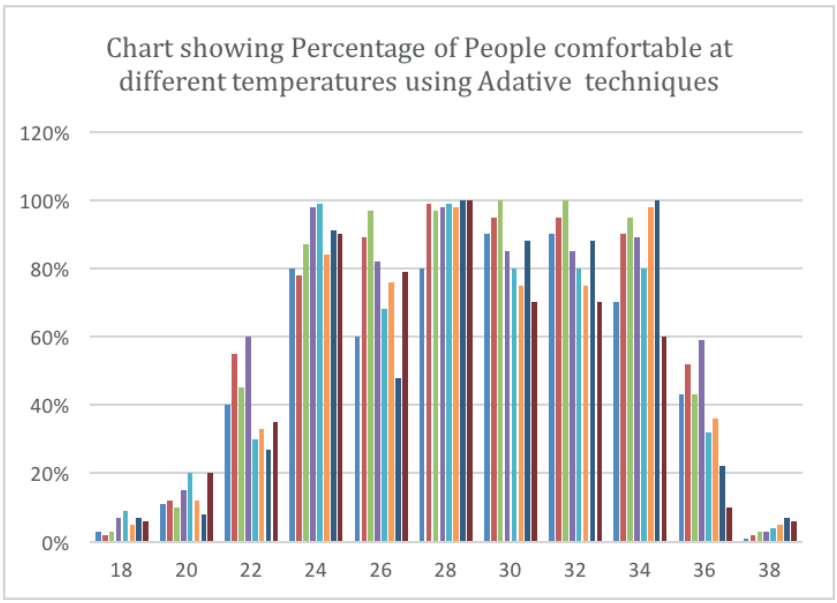
Figure 44

Mean Indoor Temperature in Degree Celcius (NBC 2005 - 24°C to 30°C). The adaptive measures allows the occupants to stretch their comfort levels to 36°C which is 6°C higher than the stated comfort levels. The clo value considered is 1 and metabolic rate is 1 as its sedentary position. With household work it can reduce by 2°C approximately. Woman in the house finish cooking early by 10.00am during summers to avoid excess heating post 12.00 till early evenings. From 70% to 100% people are satisfied with temperatures between 24°C to 34°C

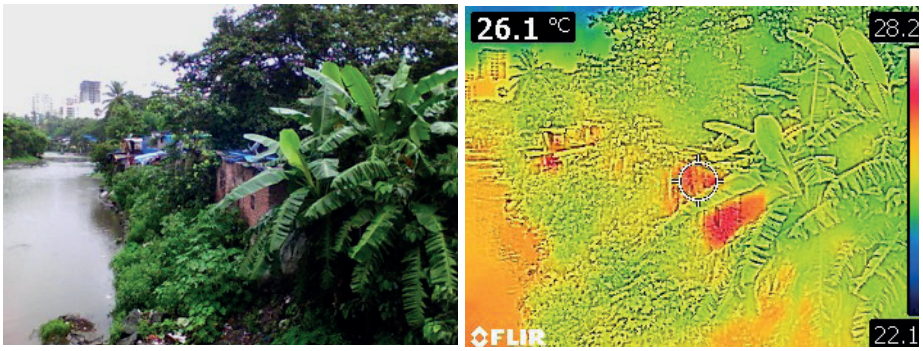
Figure 45

The settlement is built in the river bed. The thermal image clearly demonstrates the units radiating heat (blocks in red) within the dense vegetation.

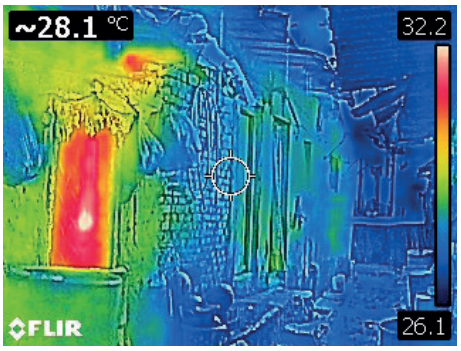
Figures 46 & 47

Pictures depicting the internal aisles within the settlement. The doors are the only source of opening within the unit. Thus heat exchange takes place through doors which is clearly depicted in the thermal image above. The kitchen is located next to the door in 8ft x 12ft unit. The women within the community experiences stuffy indoor conditions with oppressively high humidity and temperature levels especially in summers.

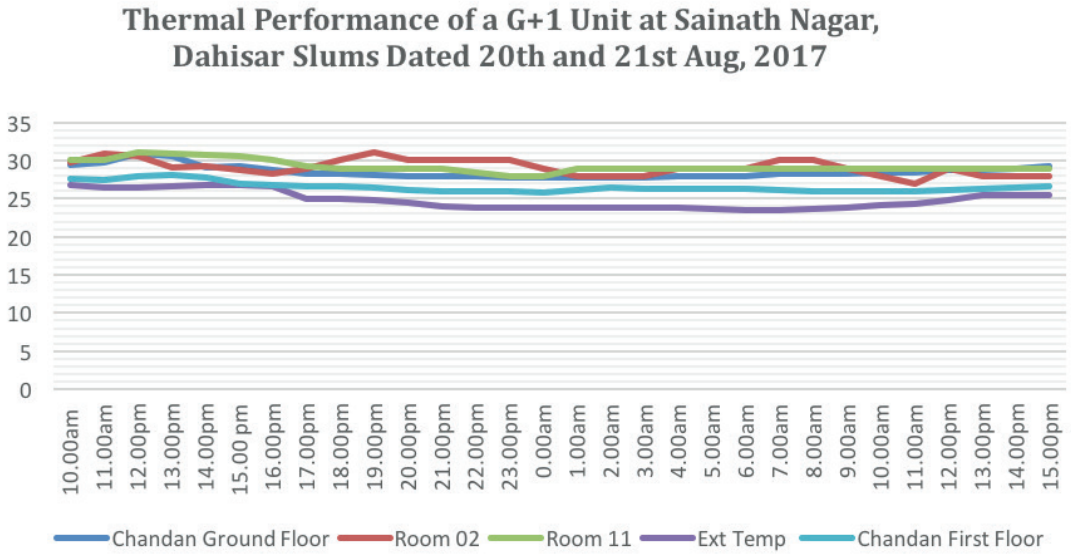
Figure 54

Temperature recording in housing unit monitored on site

The houses are being made by the people itself using bricks and mortar. Amongst all outdoor surfaces expect the front façade, all are not plastered to withstand weathering conditions. The data shows the poor performance of the unit especially the ground floor compared to the first floor. Lack of ventilation prevents lowering of internal temperature and relative humidity. The internal temperatures are approximately 5°C higher than outdoor temperature. The RH is also high, making indoors suffocating and unbearable especially during afternoon time; hence the women in the house prefers to spend time outdoors performing household chores just outside their houses. All the houses have similar indoor conditions owing to the similar built forms and patterns of living.

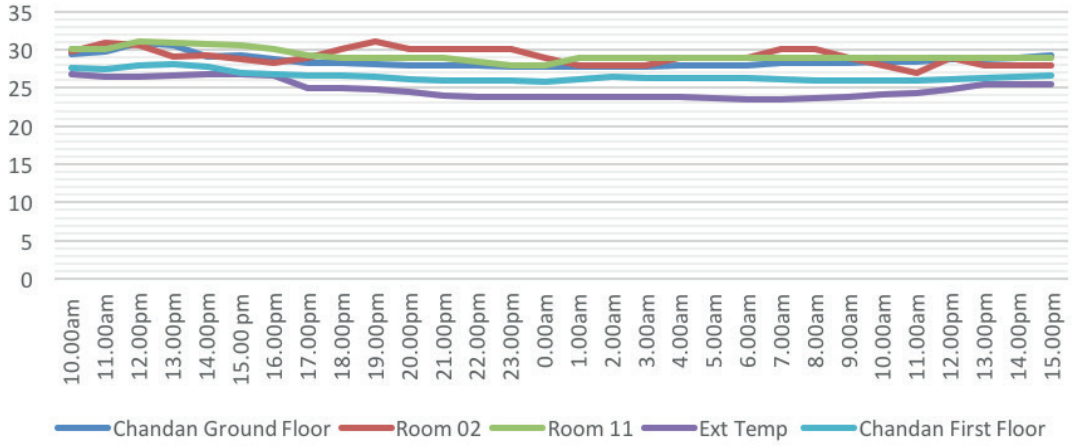
Figure 55

Humididty recording in hosing unit monitored on site.
Thermal Performance of a G+1 Unit at Sainath Nagar, Dahishar Slums Dated 20th and 21st Aug, 2017

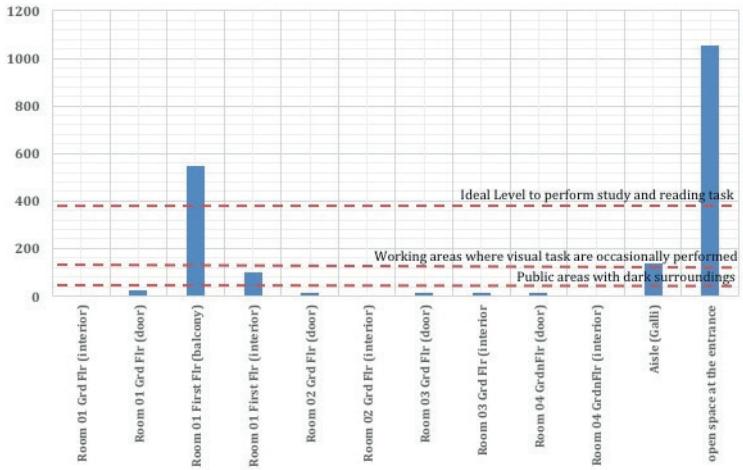
Figure 56

Daylight levels within housing units monitored on site

The daylight levels are poor and thus children prefer verandahs and upper storey for studying purposes. The artificial light is constantly on during the entire day in the ground storey structure. The advantage in upper storey structure is the placement of window on two sides; facilitating cross ventilation and ample daylight ingress. However all houses are not G+1.
